## Pool Inspection Report for [REDACTED]

[REDACTED], Gloucester, Virginia, 23061

**Inspection Dates:** May 7, 2026 (Visual), May 11, 2026 (Leak Survey)

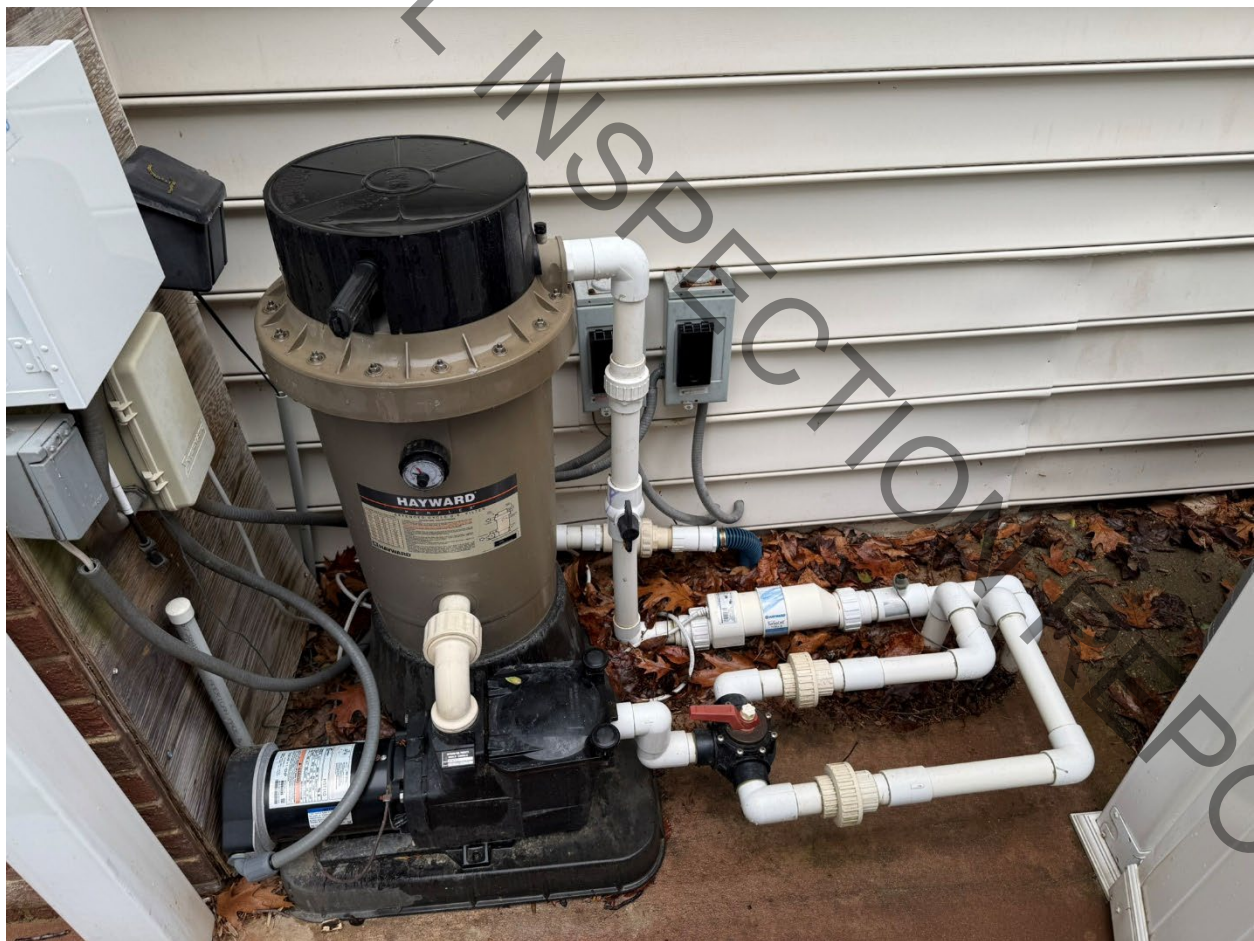
Leaves and organic debris were present around portions of the equipment area at the time of inspection. Organic debris was present near equipment, plumbing, and electrical components. The equipment area should be maintained clear enough to allow access, inspection, operation, and service of pool equipment and electrical controls.

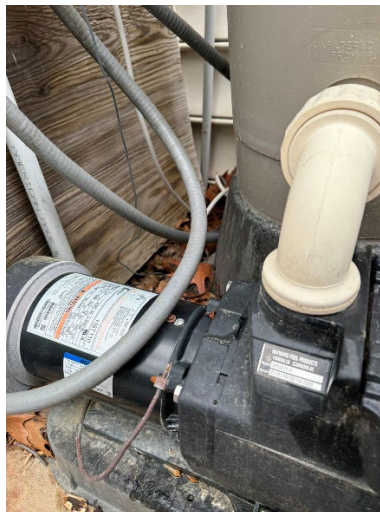
The Hayward Super Pump manual states that damaged wiring should be replaced immediately and that conduit should be located to prevent damage. The cracked/damaged conduit or raceway serving the pump motor should be evaluated and corrected by a licensed electrician using wiring methods, fittings, conductors, grounding, bonding, and GFCI protection suitable for the outdoor pool equipment environment.

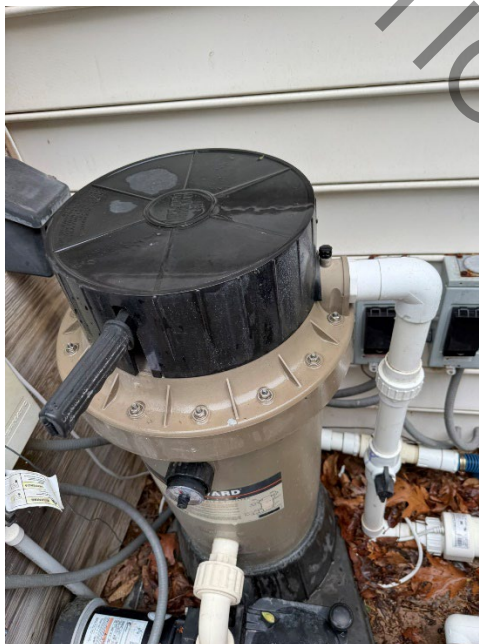
Access around the filter was somewhat limited due to the equipment layout and surrounding conditions; however, access remained available for general service and visual inspection of the exterior filter components. The equipment area should be maintained clear enough to allow safe access for operation, pressure monitoring, cleaning, winterization, and service of the filter and related circulation equipment.

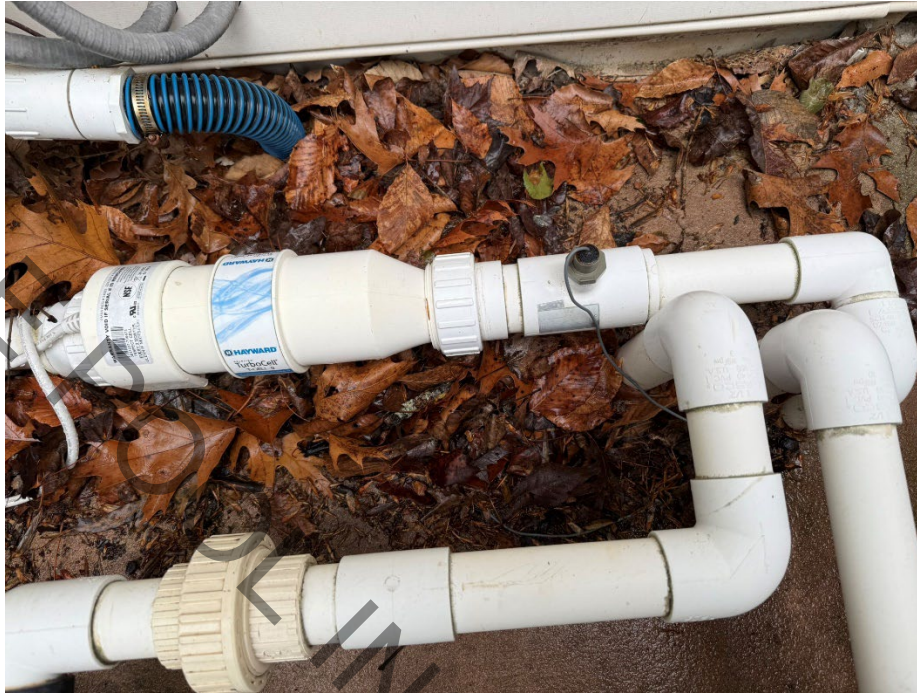
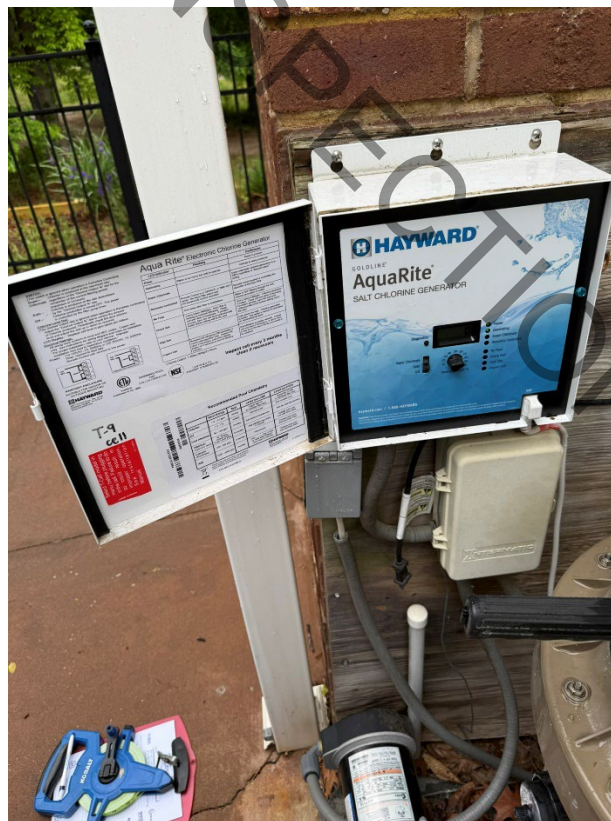
## Mechanical Time Clock

The pool circulation pump and Hayward AquaRite salt chlorine generator are controlled by an Intermatic T104P3 mechanical timer. The installed timer uses an Intermatic T104 24-hour dial time switch mounted in a plastic NEMA 3R-rated enclosure.

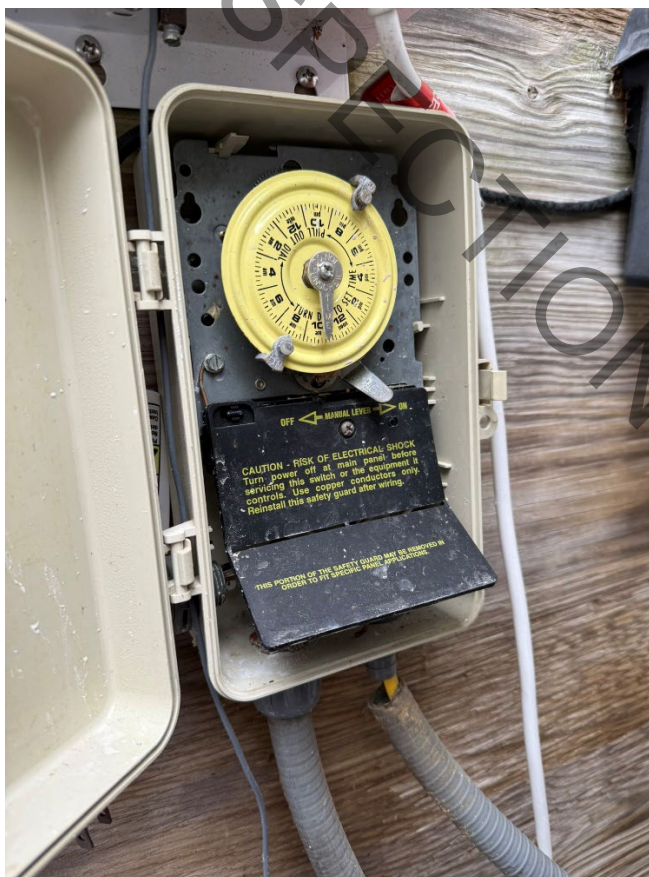
The timer function was observed only under the conditions present at the time of inspection. Long-term timer accuracy, full 24-hour dial operation, enclosure weather resistance, conductor condition, internal terminations, grounding continuity, bonding continuity, and concealed wiring conditions were not verified.

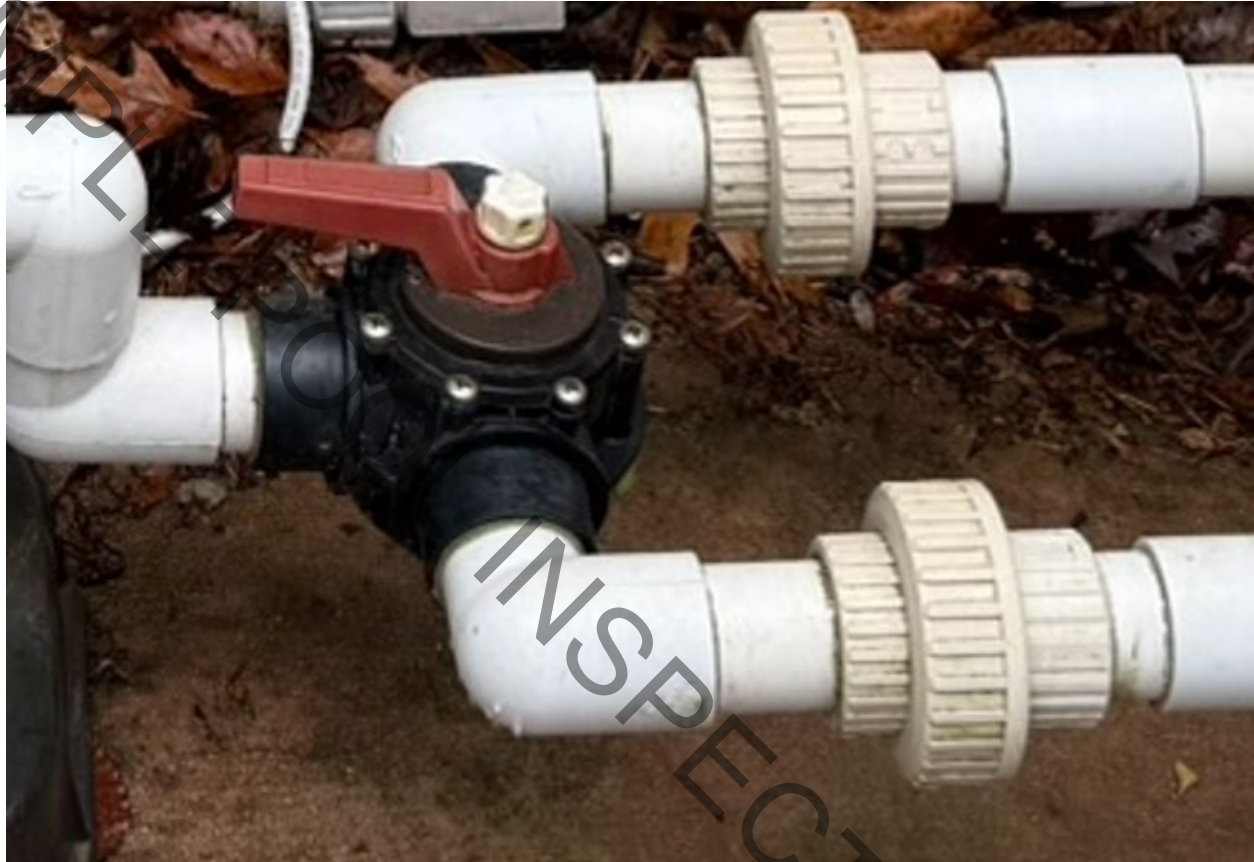
No visible leaks were observed at the three-port valve, ball valve, or immediately adjacent fittings during system operation. Site conditions were wet at the time of inspection due to recent weather, which limited the ability to distinguish minor seepage from surrounding rainwater or site moisture.

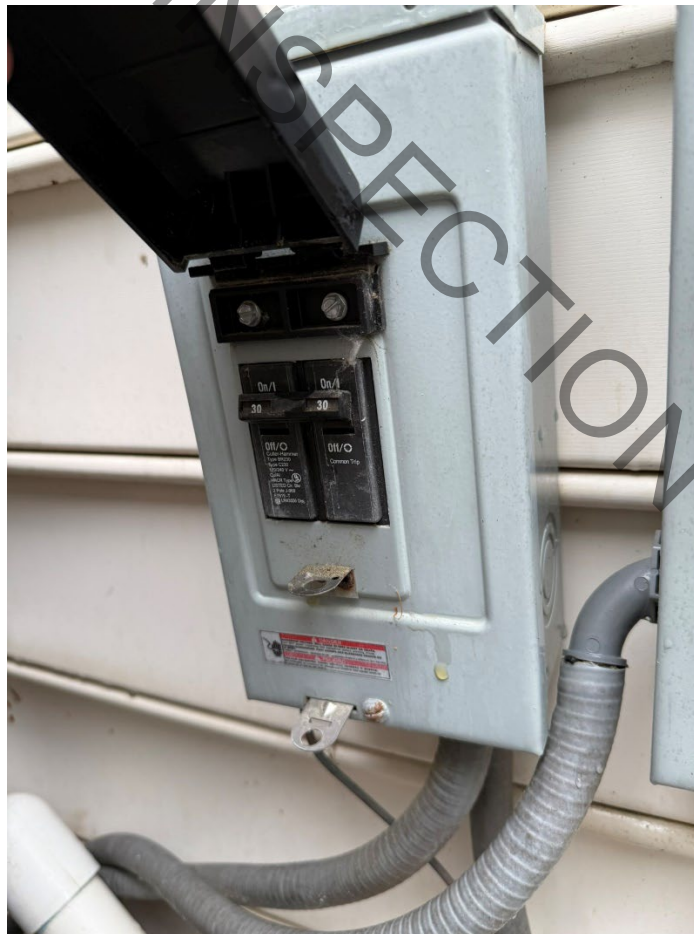
## 120-Volt GFCI / Receptacle / Deck-Light Timer Circuit

A separate 120-volt, 20-amp GFCI-protected circuit was identified. The circuit appeared to originate from a 20-amp single-pole GFCI breaker in the main house electrical panel and feed a 20-amp tandem breaker in a separate exterior enclosure. The left side of the tandem breaker was identified as feeding the nearby 15-amp duplex receptacle. The right side of the tandem breaker was not fully identified during the inspection.

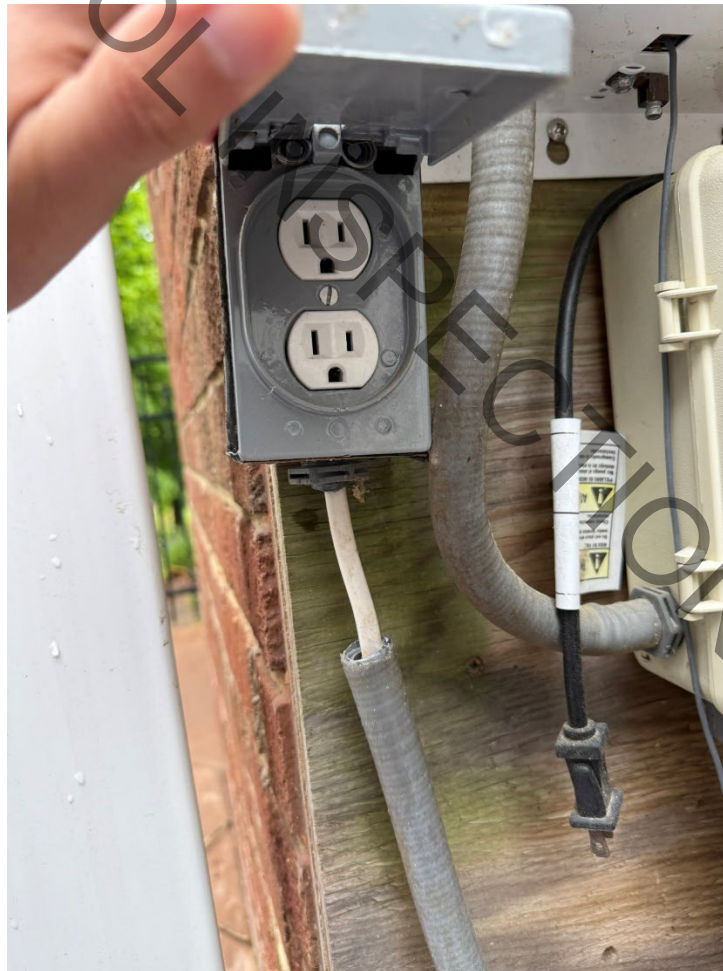
The 15-amp duplex receptacle near the pool equipment area did not have a while-in-use weatherproof cover. Because the 120-volt Intermatic/NEMA outdoor timer was plugged into this receptacle, the receptacle cover would need to remain weatherproof while a plug is inserted.

The receptacle box also appeared to require remounting or securement. Receptacles and boxes are required to be properly installed and secured. The receptacle, box, cover, mounting, wiring method, cord-and-plug connected timer, and GFCI protection should be evaluated and corrected by a licensed electrician.

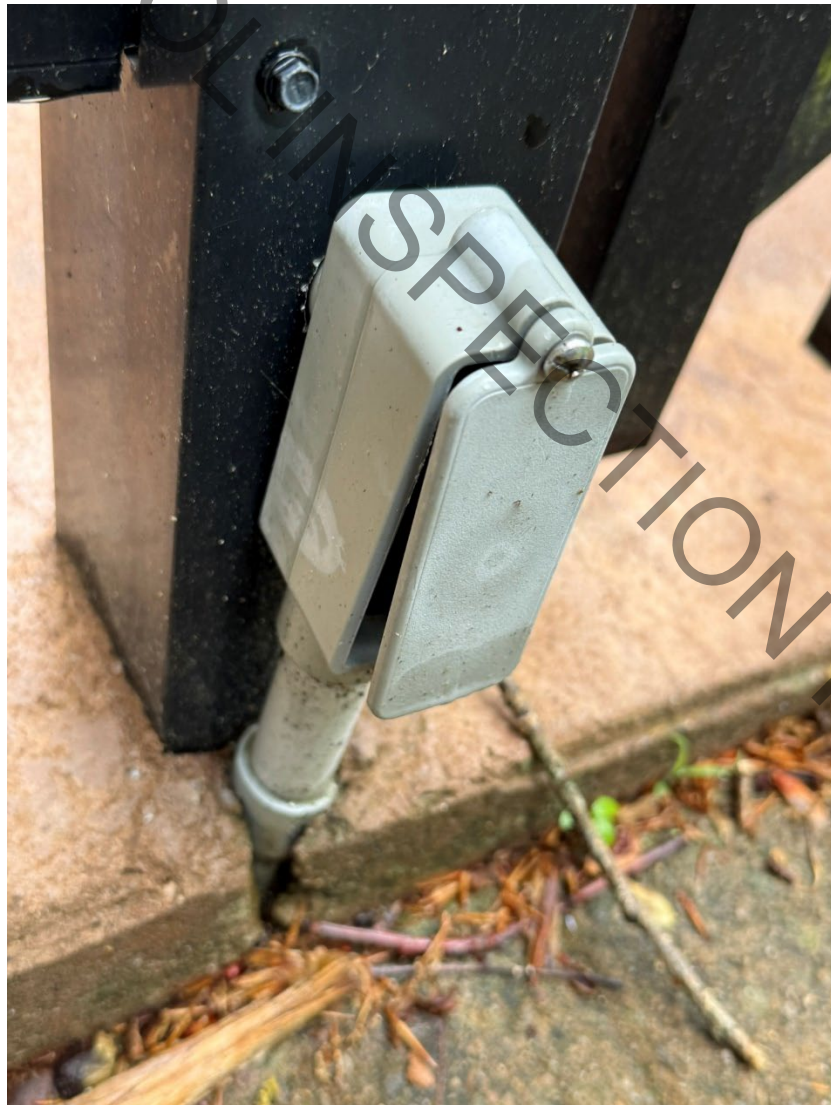
One junction box cover associated with the light wiring was observed missing a fastener and was loose. Loose or unsecured junction box covers can allow moisture intrusion, expose wiring to weather, and reduce the integrity of the electrical enclosure.

All pool-area lighting junction boxes should be inspected and corrected by a licensed electrician. Covers should be properly secured with approved fasteners, and all boxes, covers, fittings, gaskets, and wiring methods should be suitable for the outdoor/wet pool-area environment.

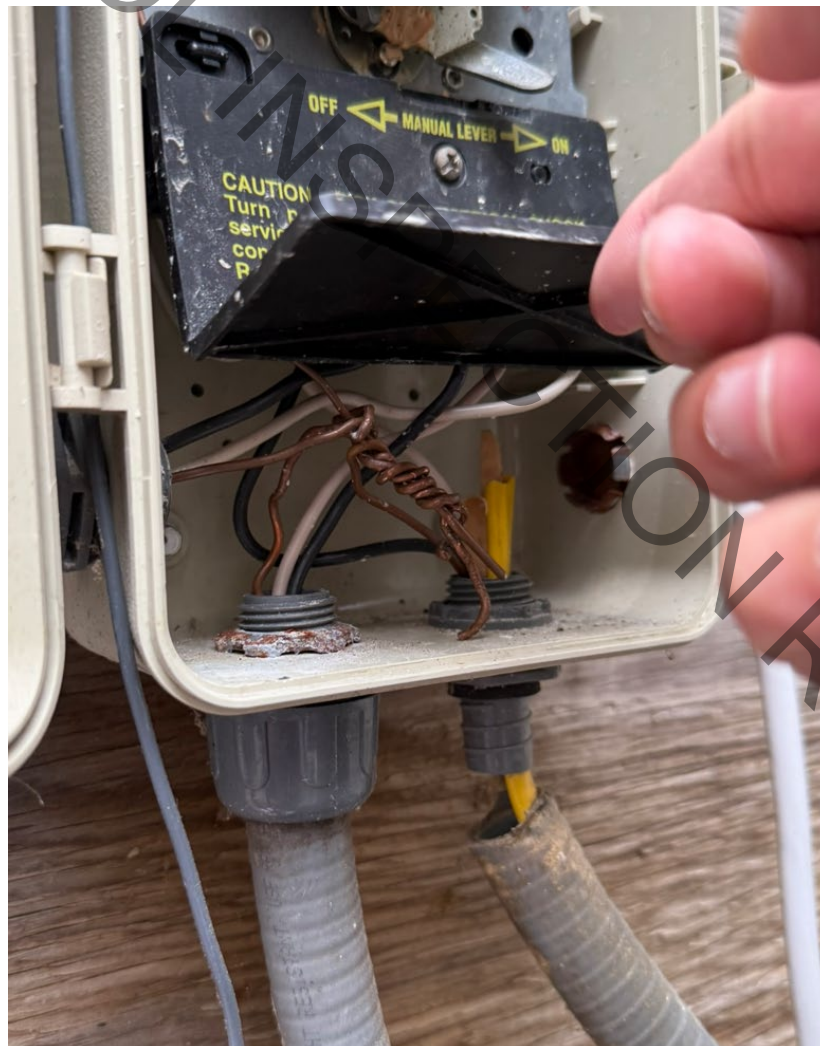
NM-type cable, commonly referred to as Romex, was observed in portions of the pool-related electrical wiring. Type NM cable is not permitted in wet or damp locations. 2020 NEC 334.12(B)(4) prohibits Type NM cable from being used in wet or damp locations.

The presence of a weather-resistant enclosure or raceway does not automatically make NM cable suitable for outdoor pool equipment wiring. Under 2020 NEC 300.9, the interior of raceways installed in wet locations above grade is considered a wet location. Conductors and cables installed in wet locations must be listed and suitable for wet-location use.

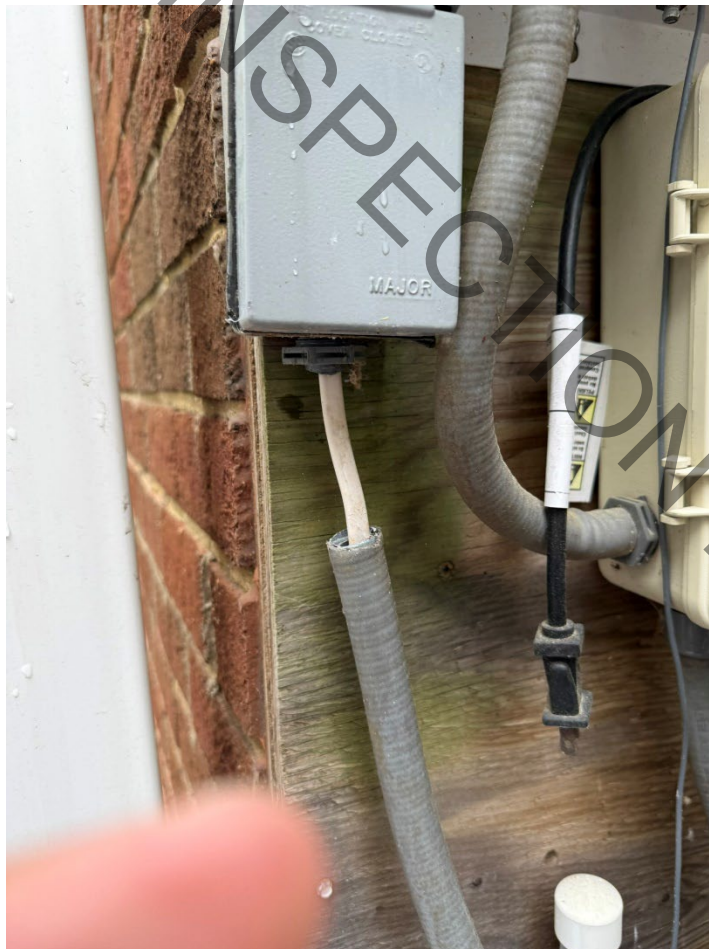
Electrical conduit and raceway issues were observed in multiple locations. Observed conditions included damaged or deteriorated conduit, questionable raceway transitions, and wiring/raceway arrangements requiring further evaluation.

All conduit, fittings, raceways, boxes, and terminations serving the pool equipment and pool-area lighting should be evaluated and corrected by a licensed electrician using wiring methods approved for outdoor, wet, and pool-equipment environments.

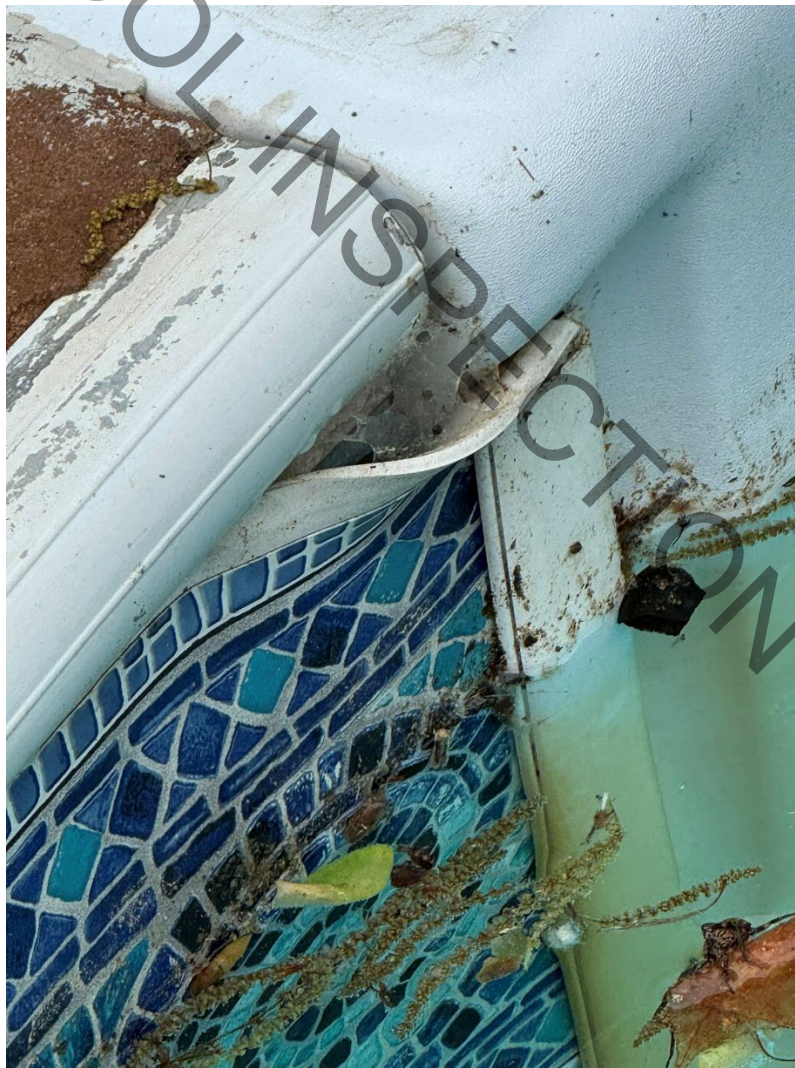
At the step area, the coping/liner track and step assembly did not align cleanly in one location, leaving a gap/transition area where the liner was not fully secured. This condition is also noted above under the Vinyl Liner observations.

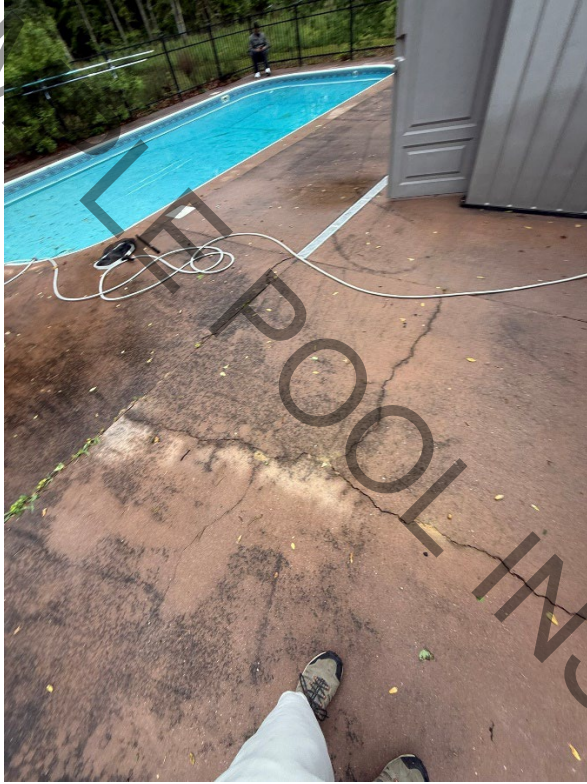
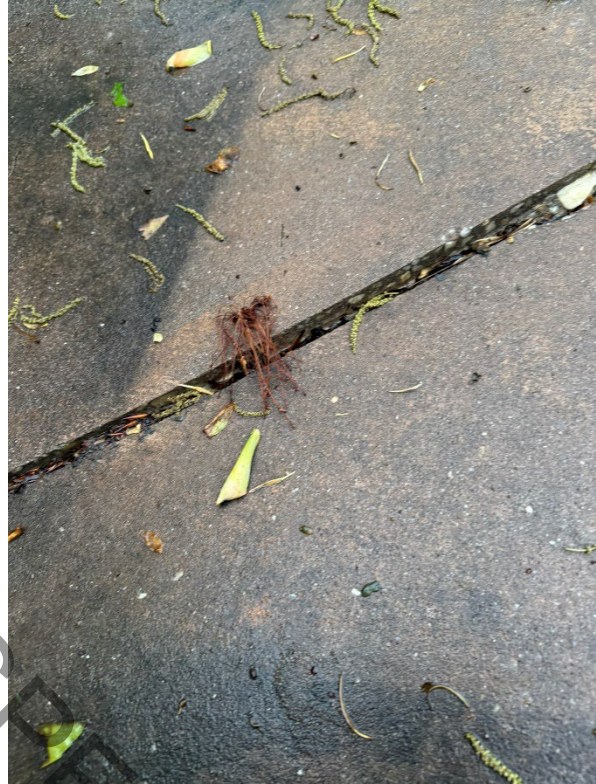
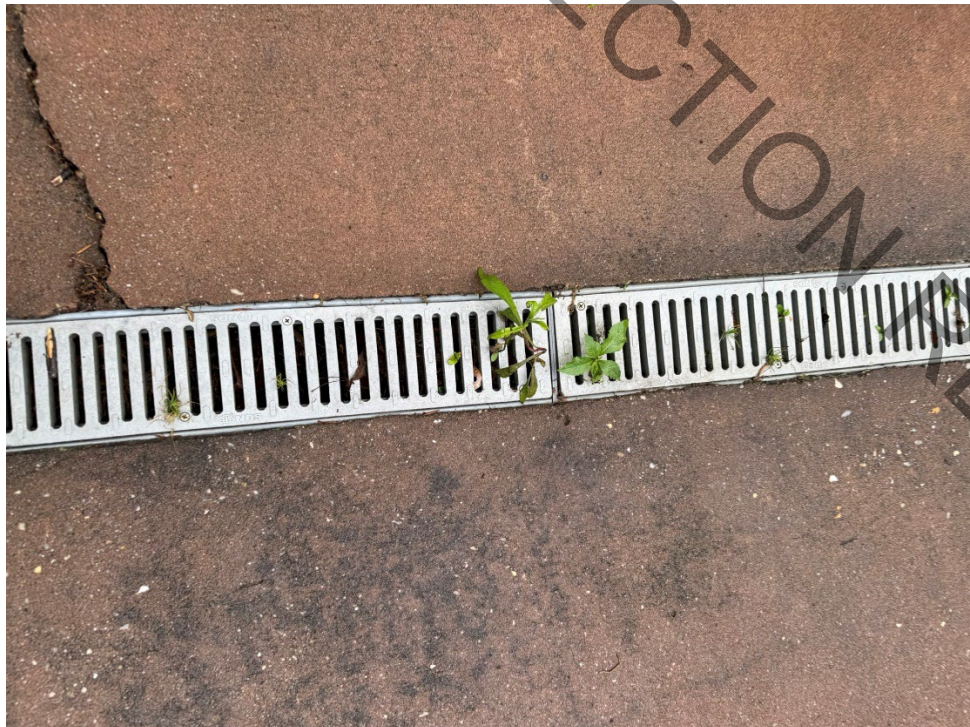
drainage conditions. The deck should be further evaluated and repaired by qualified professionals as needed.

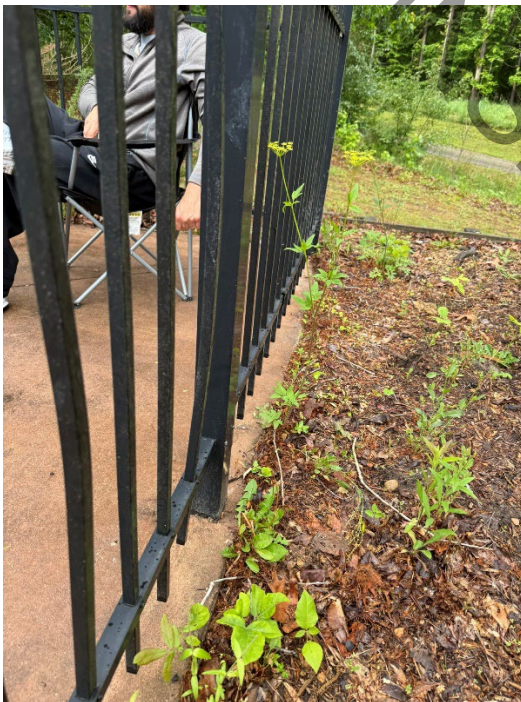
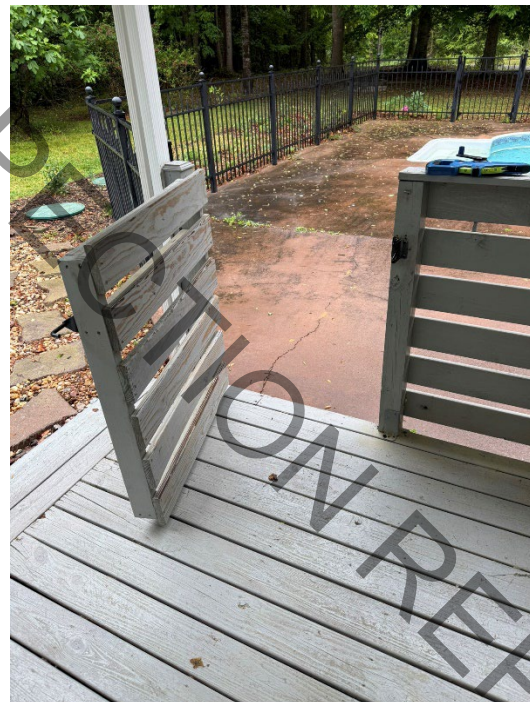
Barrier corrections should be performed by qualified personnel, and final acceptance of barrier compliance should be determined by the authority having jurisdiction where required.
